Hog iPC Video Card Riser Reengagement

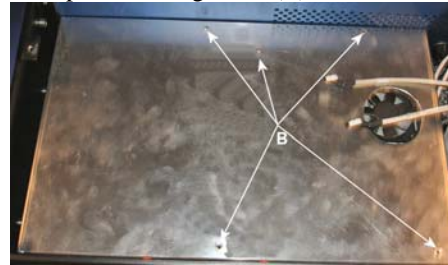
The video card riser board used within the Hog iPC console may become slightly dislodged after rough shipping. When this occurs, users will experience loss of the second and third video outputs. High End Systems recommends this simple procedure to reengage the video card connection. If problems with the video card riser connection continue, contact HES support at 800-890-8989 or support@flyingpig.com

1. Remove the front panel retaining screws (A) (4x- two screws on each end of the console) using a 4mm hex tool.
2. Slowly and gently lift up rear of the front panel and disconnect the cable connections. Note the connector labels and locations. Remove front panel and set aside.
3. Using a #2 Philips screwdriver, remove the five screws that mount the computer housing cover (B).

- a. Some older Hog iPC consoles have the wiring exiting through the top of the computer housing through a snap-in strain relief (C). Gently lift the cover and snap the strain relief up and out of the mounting hole, and then feed the wiring through the keyhole slot.

4. Gently lift up the computer housing cover so the motherboard is exposed.
5. Locate the video card and riser on the motherboard.
6. Locate the end of the video card riser board nearest the console wrist rest. Push down with slight pressure on this portion of the video card riser board until the card reengages into the slot.
 - a. Take care to only press on the green board so as to not bend the video card socket.
