# Flying Pig Systems

## Wholehog II Expansion Wing Hardware design errors - fixes

Two hardware errors have been found in the design of the Expansion Wing.

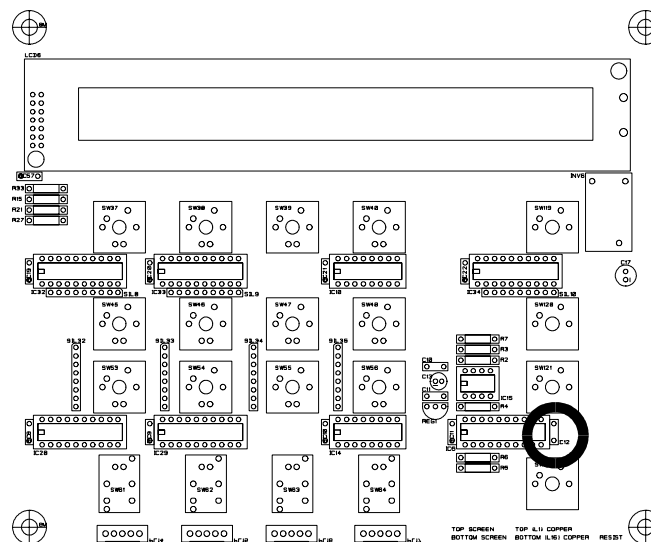
*Serial numbers affected by error #2: 0228 - 0260*

The faders may not zero correctly or may twitter about zero in hot conditions. This will cause the Flash LEDs to flash or flicker if intensity information present in the assigned Cuelist. The Event Monitor can be used to confirm this condition, you will notice a frequent Wing fader events.

Capacitor C12 should be removed from the PCB by a qualified technician. This modification can be performed **WITHOUT** removing the PCB from the metalwork – consult the diagram below for the whereabouts of this capacitor in the bottom righthand corner of the board.
